NTSB Battery Nail Penetration Tests

Final Report for 787 Battery (Asset 436) Tested at 70°C, Ungrounded

J. Thomas Chapin, PhD
Pravinray D. Gandhi, PhD, PE
Paul W. Brazis, Jr., PhD
May 29, 2014

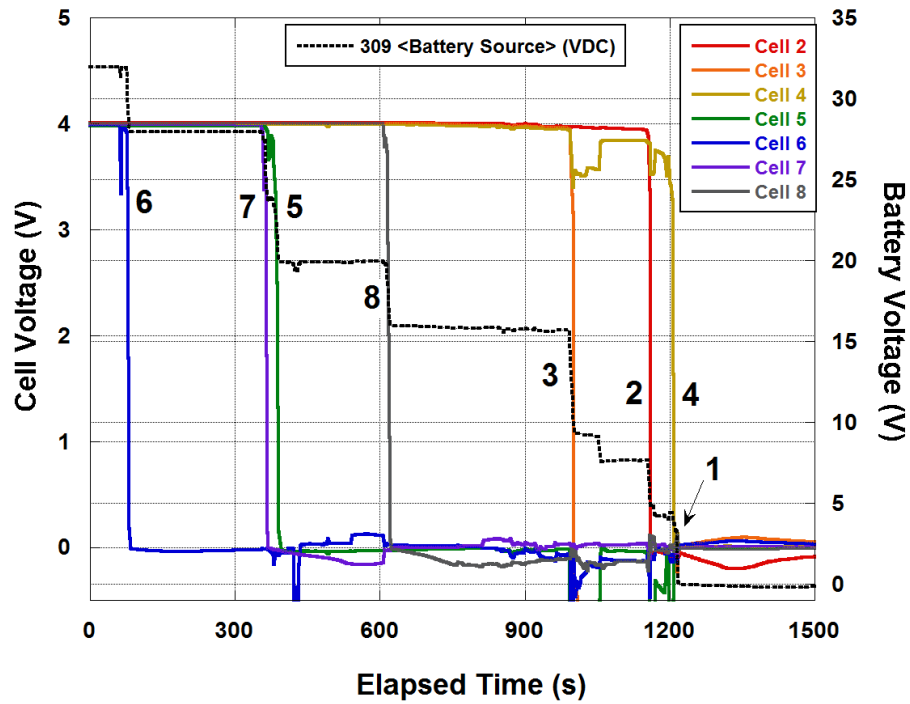
Figure 38. Plot of cell voltages and battery voltage, measured through entire test.

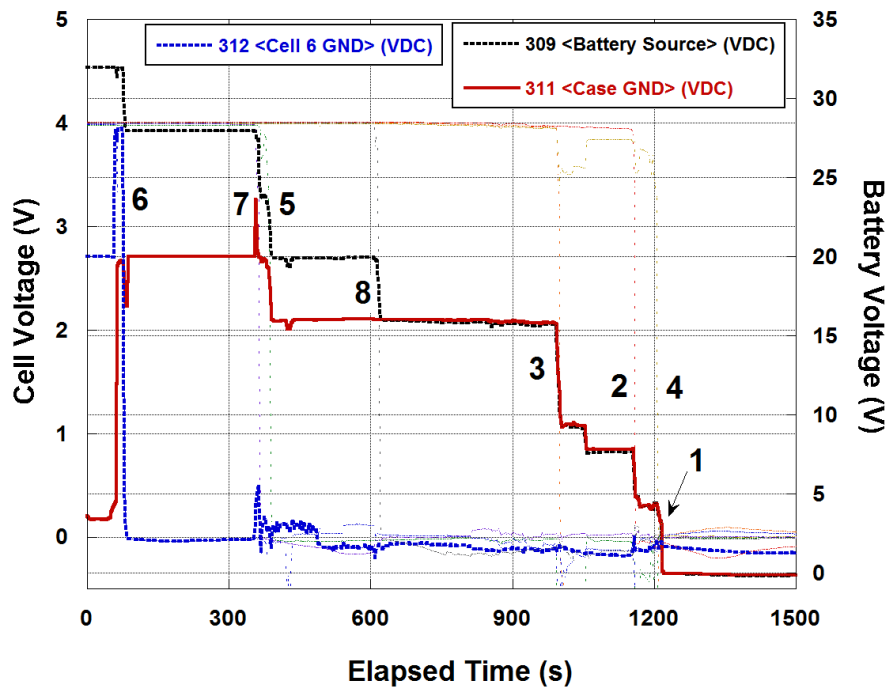
Figure 39. Plot of battery voltage, with case ground voltage and Cell 6 case voltage shown.

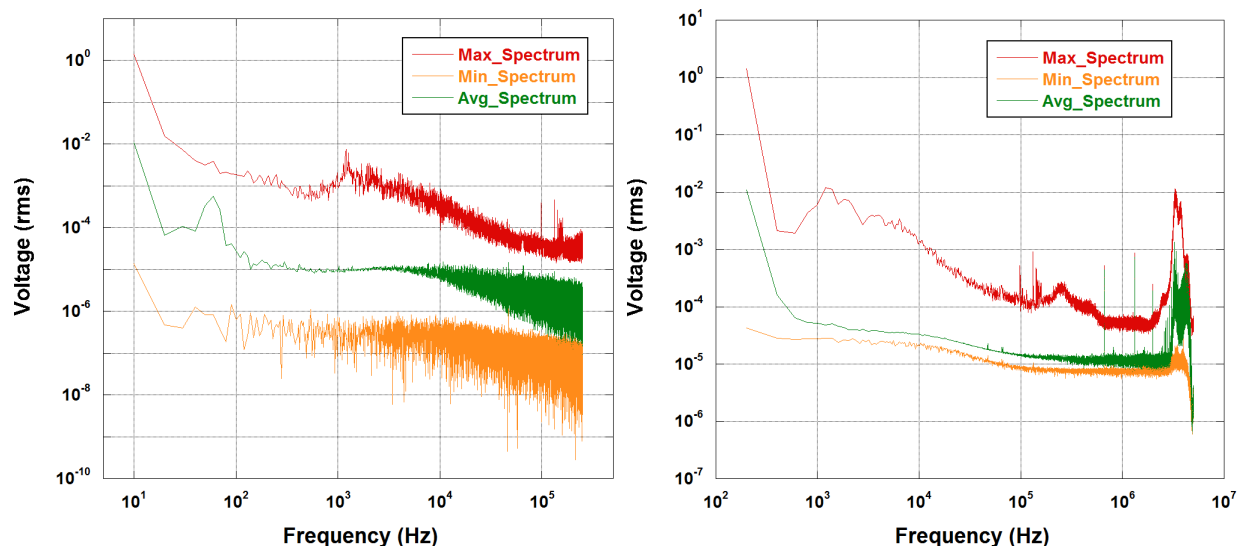
Figure 40. Maximum, minimum, and average spectral values recorded over the duration of the test. (Left) Sampled at 500 kS/s with 10 Hz resolution. (Right) Sampled at 10 MS/s with 200 Hz resolution.

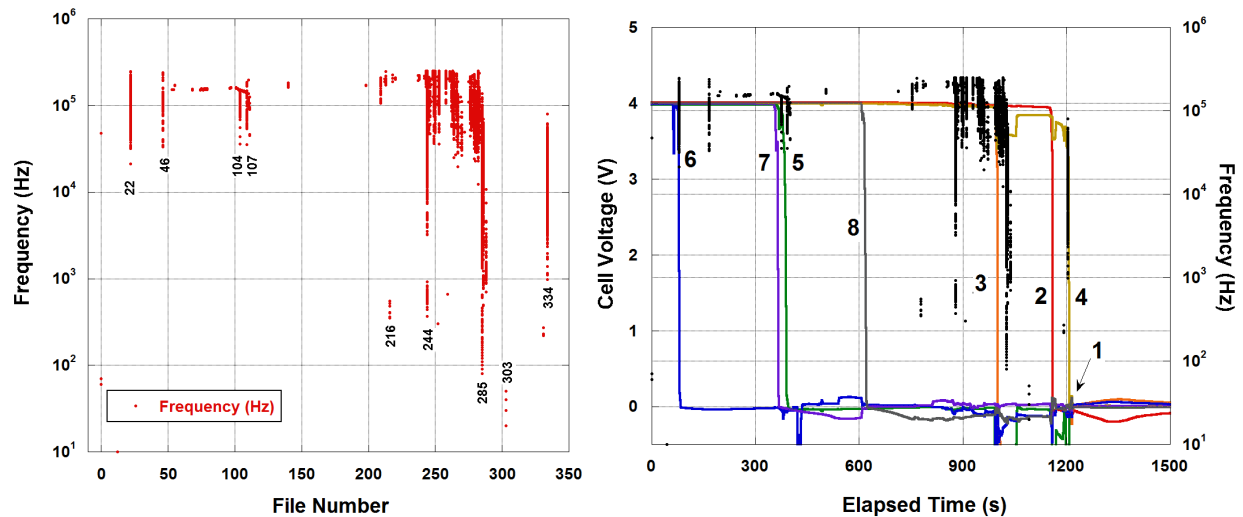
Figure 41. Location with respect to (left) file number and (right) test time of maximum amplitude for each of the 50,000 frequencies tracked in each of the 740 spectral files. At right the data are superimposed onto cell voltage data. Left plot lists file numbers with the most significant number of recorded maxima.

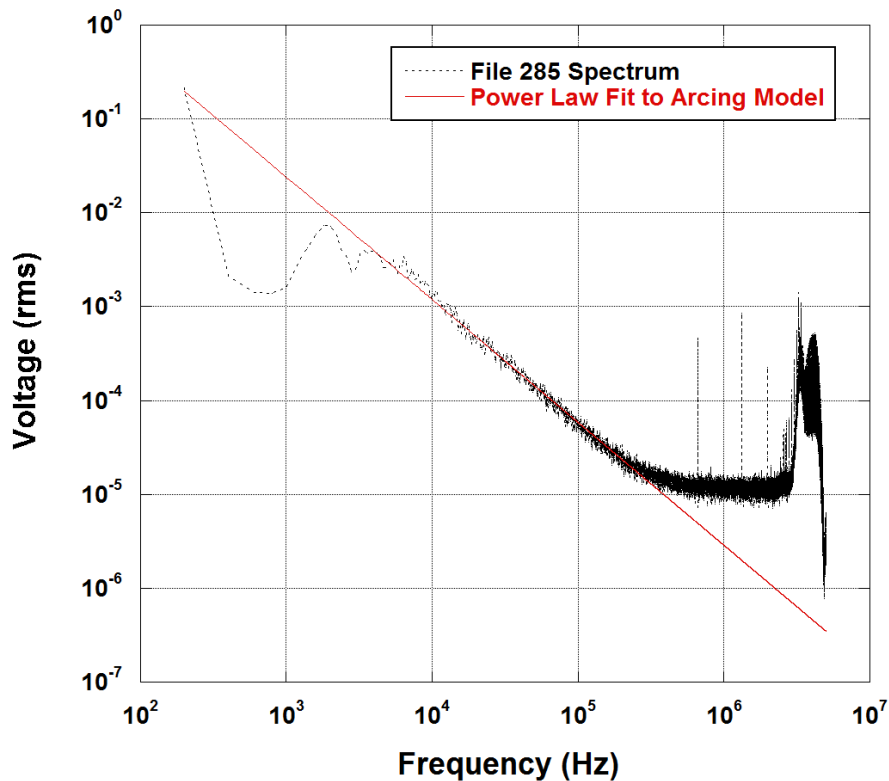
Figure 43. Power law fit to spectral data observed during Cell 4 discharging event (File 285), showing agreement with power law fit that is consistent with electrical arcing behavior. Flattening and artifacts above 250 kHz are result of noise floor and equipment noise, respectively.

The high-frequency data were analyzed using automated software, which collected statistical information on the recorded spectra. The evaluation shows several potential occurrences of electrical arcing, though the spectral content below 1 kHz was observed to be less than would be expected. The most significant spectral content was observed during the high-current discharge of Cell 4, with the observable power law relationship suggesting that spectral noise originates as arcing. A power law fit suggests that the spectral noise from arcing voltage falls off with respect to frequency at a rate of -13 dB/decade and arcing power is expected to diminish at -26 dB/decade.

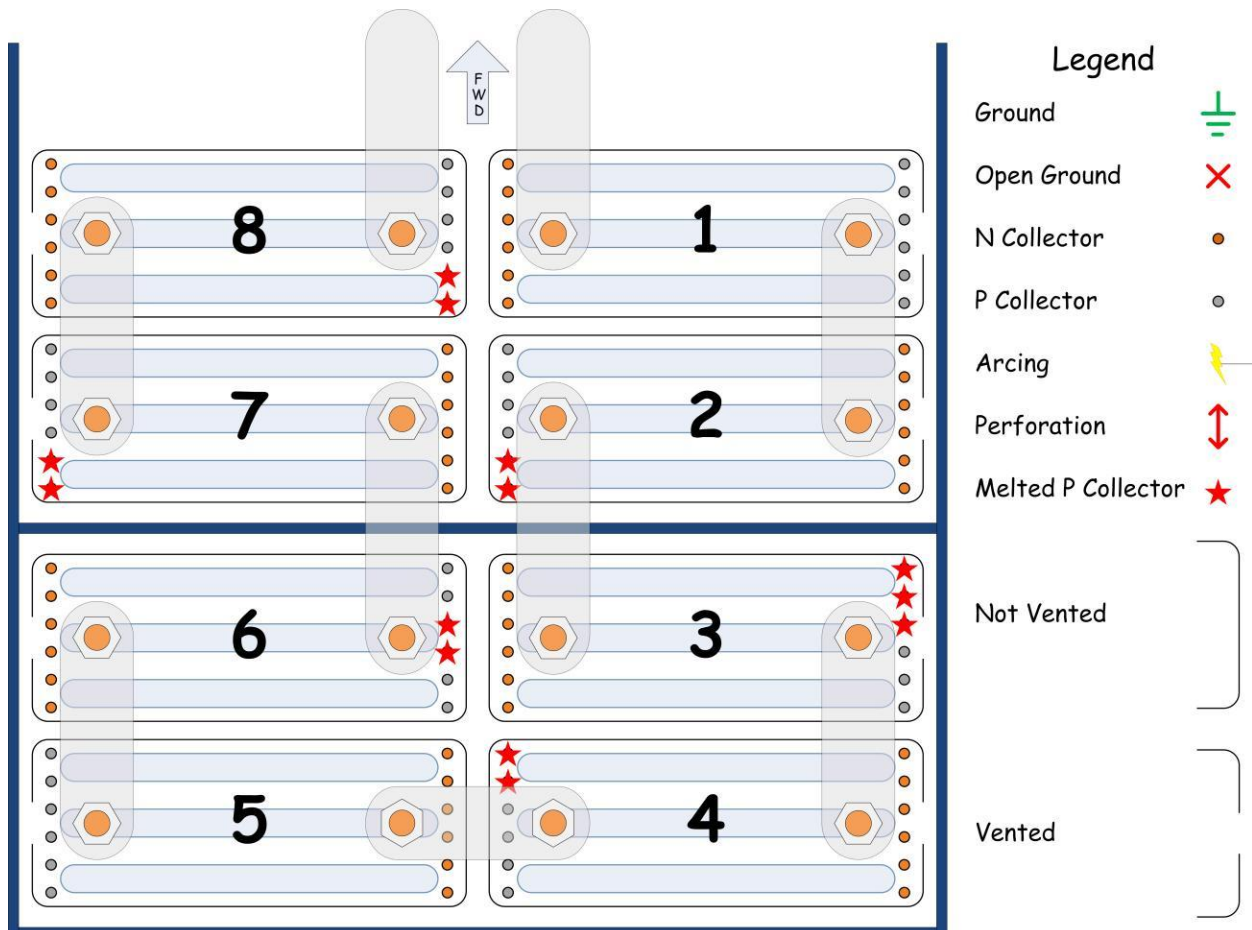
Figure 44. Locations of melted/open collectors inside each battery cell.

The battery was disassembled after discharging the cells. The photographic documentation of the disassembled battery is presented in Appendix A. Figure 44 shows the locations of each melted/open collector within each cell. It was observed that only aluminum electrodes melted/opened during the test; all copper electrodes remained intact. The pattern of openings suggests that the sub-cell to fail first results in opening of that electrode. For example, the center sub-cell on Cell 6 shows an opened electrode, which reflects the fact that the center electrode was the one driven to failure due to nail penetration. After Cell 6 failure, heat transfer from venting transferred to Cell 7, resulting in its failure. As can be seen, the sub-cell electrode within Cell 7 located closest to Cell 6 exhibits the melted/opened electrode. This is also true with Cell 8, which vented due to heat transfer from Cell 7, and also shows opened electrodes closest to Cell 7. This is also observed in Cells 2 and 4, which both vented as a result of heat transfer from Cell 3.

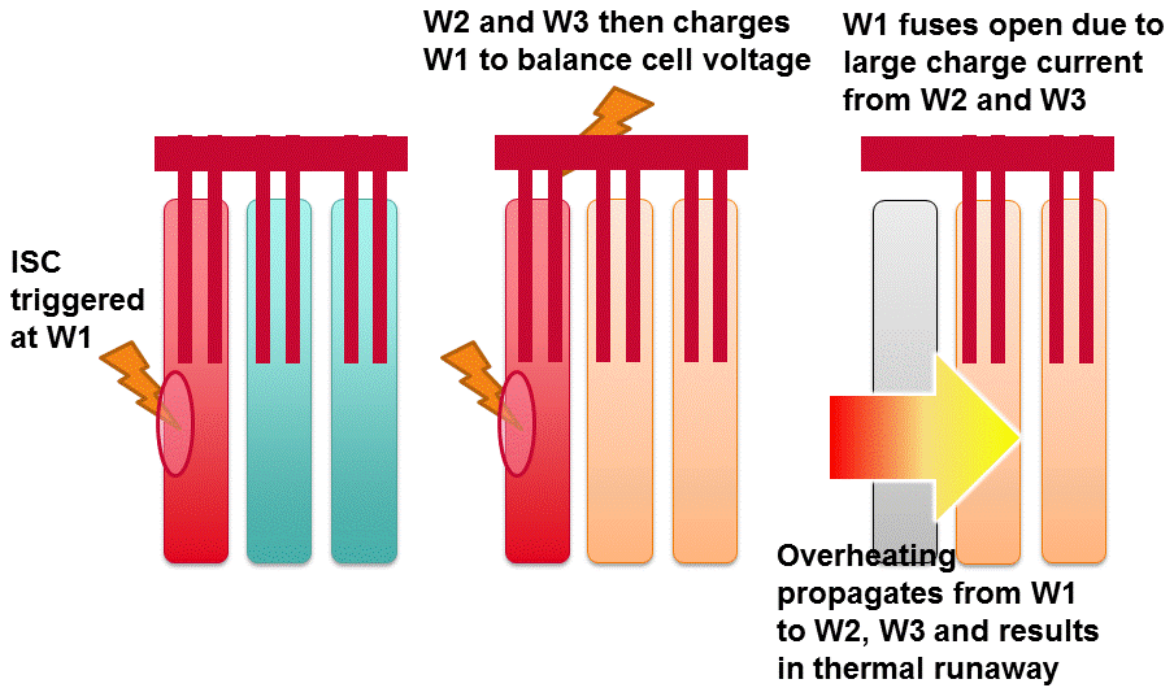
Figure 45. Proposed failure mechanism for cells.

This pattern of failure suggests the failure mechanism as shown in Figure 45, and the corresponding voltage behavior is shown in Figure 46. In this model, heat transferred to the cell (e.g., from a previously

vented cell) causes one of the three sub-cells to short circuit and draw large current from the rest of the cell. This causes the aluminum electrodes to overheat and open on the cell which is in a short-circuit condition. During short-circuit the voltage of the cell drops, but then recovers once the shorted cell is removed from the circuit. The heat from the failed sub-cell then transfers to the other two sub-cells, causing thermal runaway for the rest of the cell and drop of the cell voltage to zero. This failure model suggests that the electrodes that fused open will denote the sub-cell which failed first, and is expected to help in determining the sequence of cell failure by signaling the direction of heat flow into the cell which caused failure. This also suggests that open electrodes at the center sub-cell suggests that heating originated from within the cell rather than from an adjacent cell, increasing the probability that the cell showing open electrodes at the center sub-cell only was the cell that was first to fail and triggered the entire failure event.

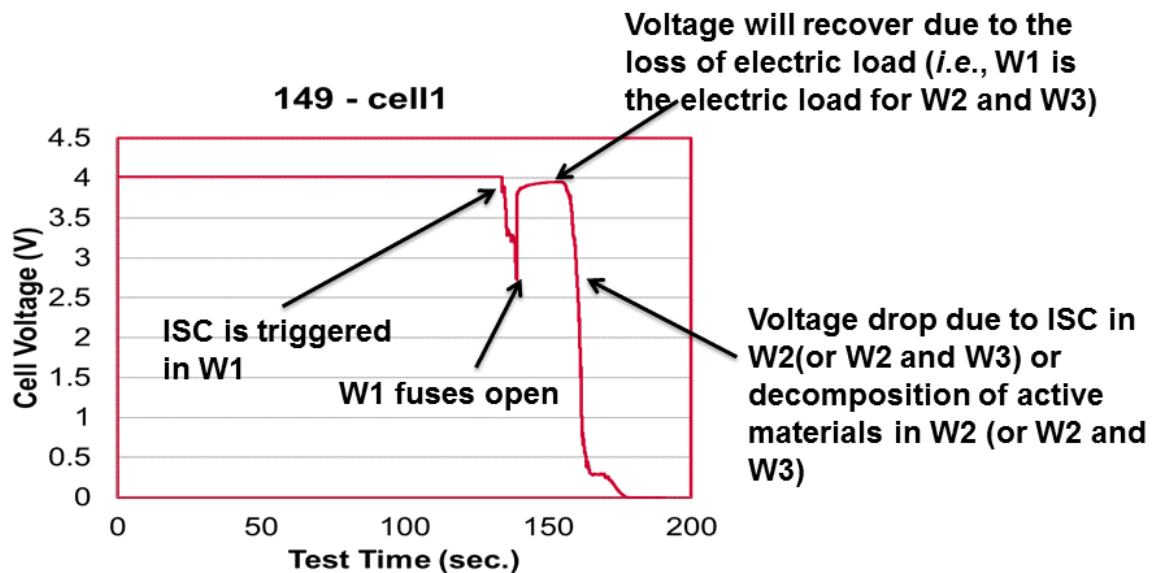
Figure 46. Cell voltage behavior during failure mechanism as shown in Figure 45.

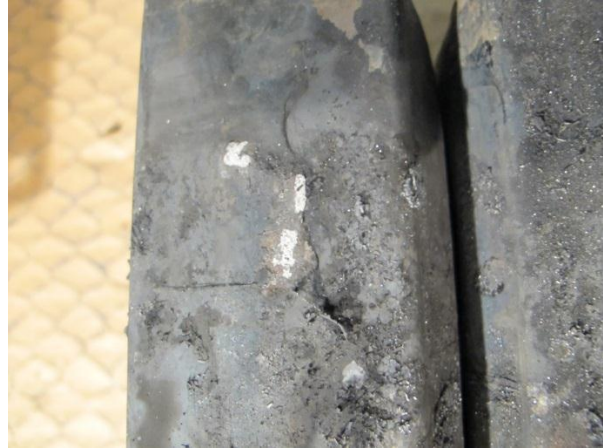
Cells 5 damage

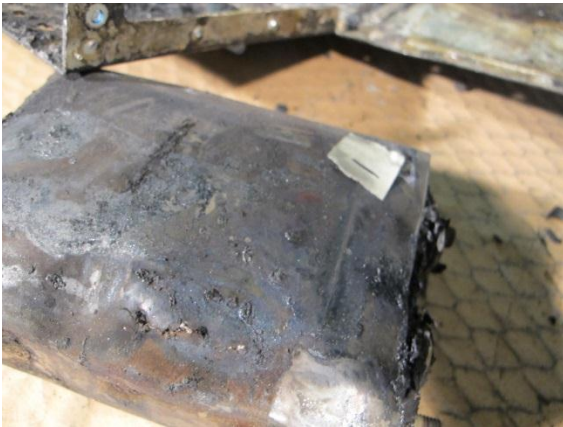
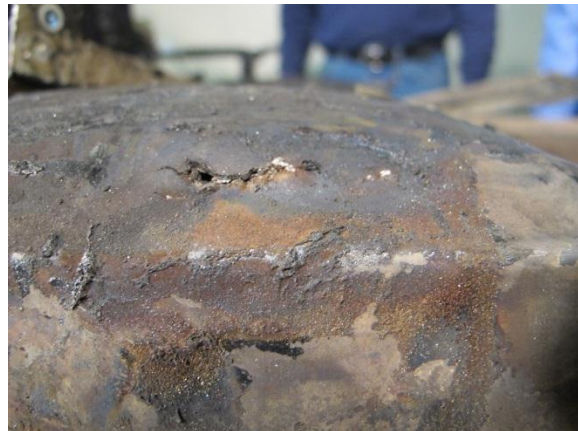
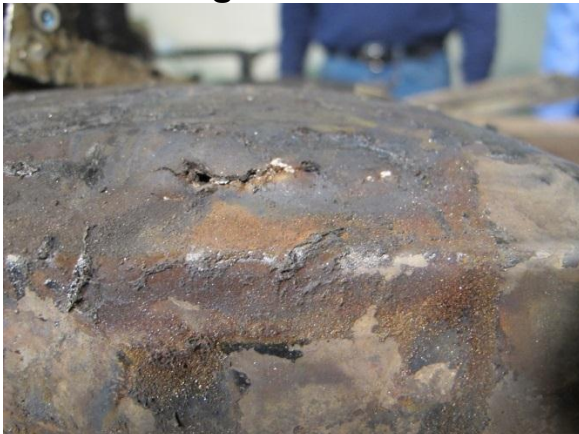
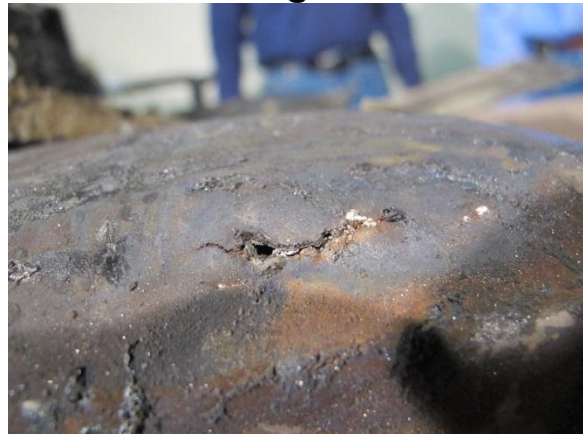
Cell 1 damage
